CANADIAN FORCES FLIGHT SAFETY INVESTIGATION REPORT (FSIR)

FINAL REPORT

FILE NUMBER: 1010-11305 (DFS 2-4)

AIRCRAFT TYPE: CH 113 Labrador

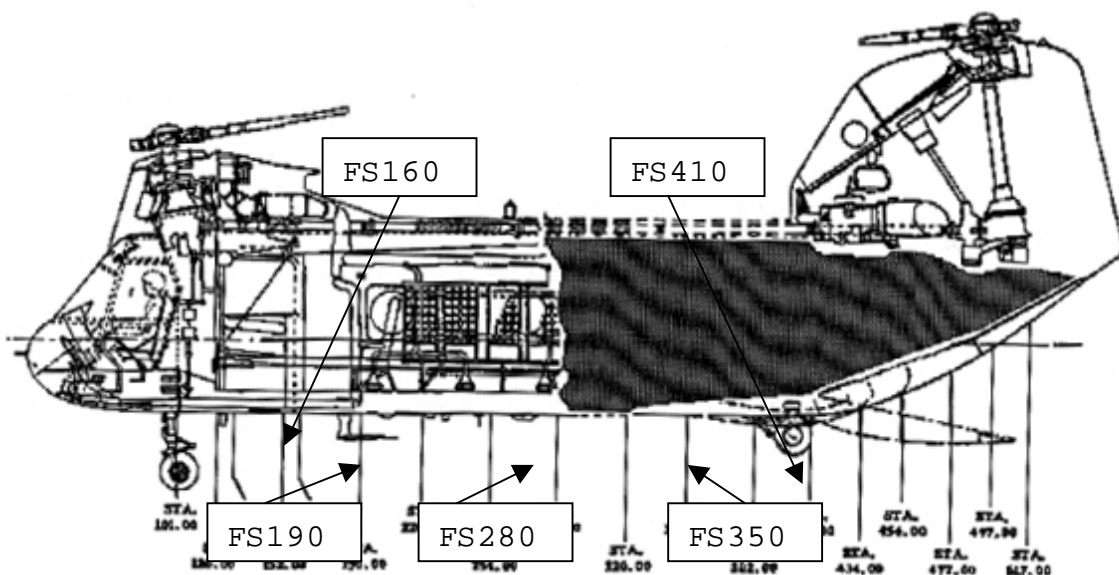
Figure 1: Flight Stations and Area Consumed by Post-crash Fire

Reconstruction of the aircraft in Ottawa revealed that the destructive forces of the accident had consumed a large section of the rear of the aircraft. None of the structure of the aircraft aft of FS 280 and above the floor remained, except the stainless steel engine compartments at FS410 and much of the rear ramp area which was scorched both inside and out. Some of the stub wing fuel tank structures and landing gear supports survived these destructive forces and the entire rear pylon and rotor head, located above the steel engine boxes, displayed little fire damage.

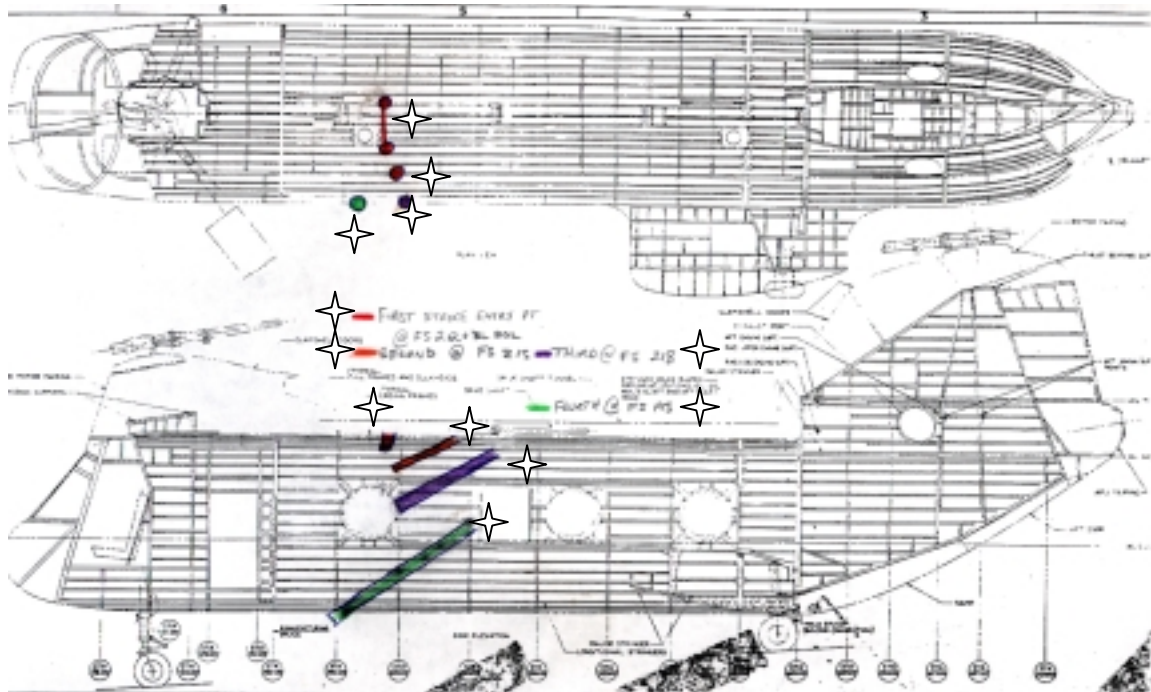
Figure 3: Blade Strike Entry Points and Damage Paths

Base Line (BL) 20 Left(L))that tore off a piece of sync shaft tunnel cover, severed the upper fuselage, cut the sync shaft and the control cables. The piece of tunnel cover from this uppermost blade strike was found at the top of the mountain in the debris field. Much of the tunnel cover was recovered and reconstruction showed that soot had been deposited on the inside right of the cover with more significant levels of soot towards the rear. The piece of tunnel cover removed by the first blade strike showed soot had been deposited before the blade contact propelled it from the aircraft. This indicates that a fire producing soot pre-existed the blade to fuselage contact.

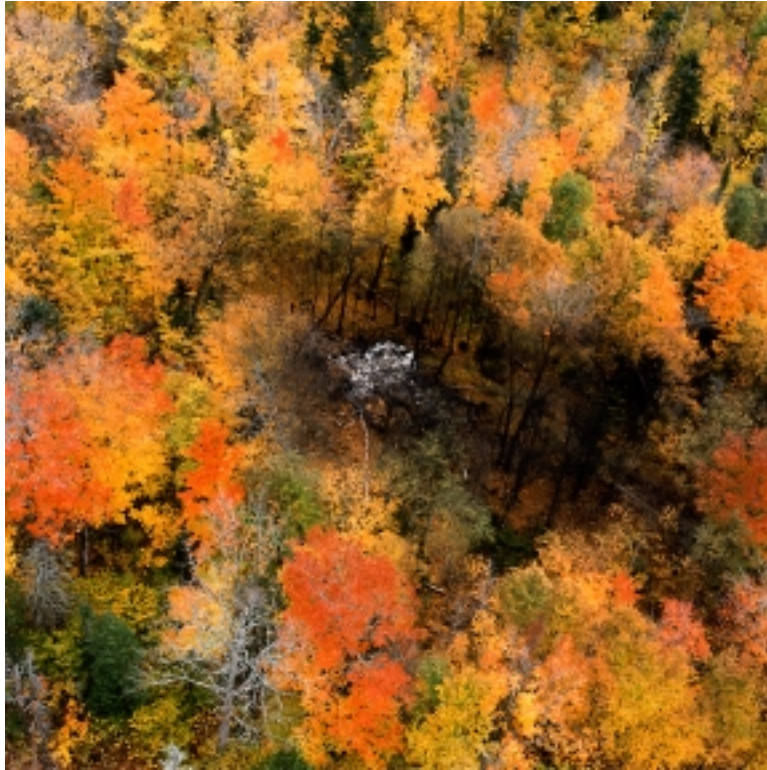
Photo 1 -Site 3 Rear Fuselage/Engines and MGB// Secteur 3 : fuselage arrière, moteurs et boîte de transmission principale

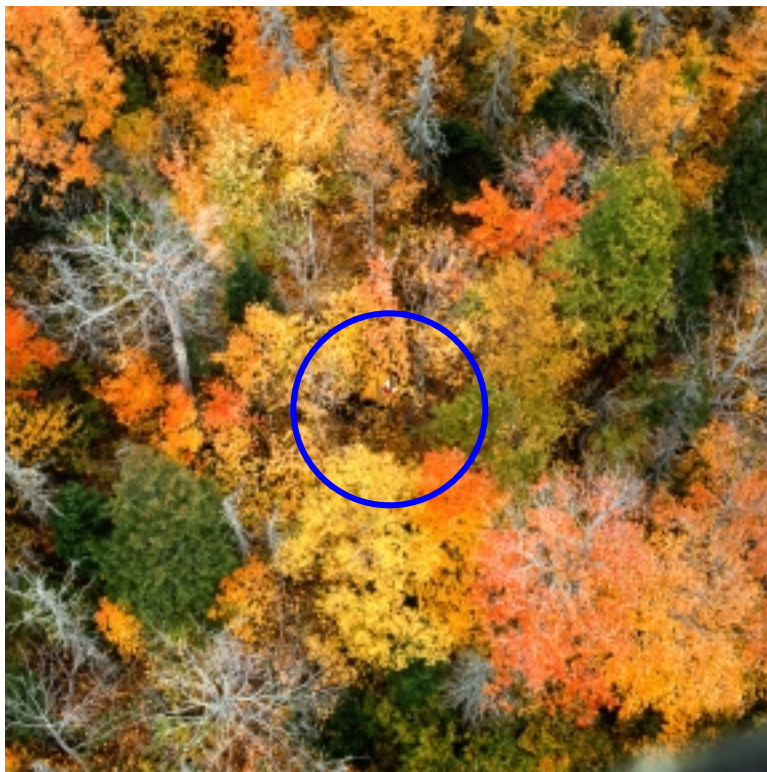
Photo 2 - Site 2 Rear Pylon (circled)// Secteur 2 : pylône arrière (encerclé)

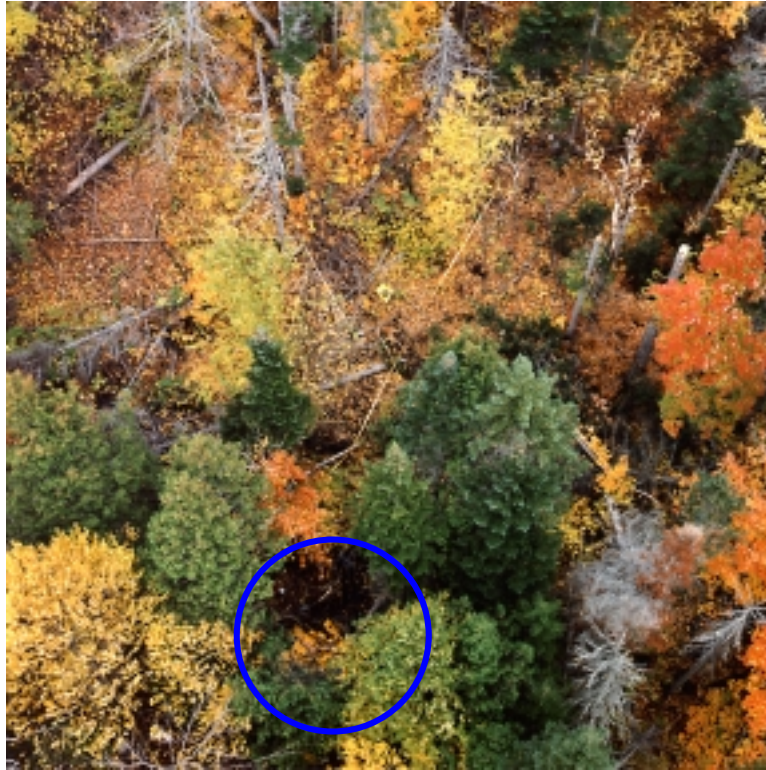
Photo 3 - Site 1 - Forward Fuselage, Flight Station (circled) and Crews Location// Secteur 1 : fuselage avant, cabine de pilotage (encerclée) et emplacement des membres d'équipage

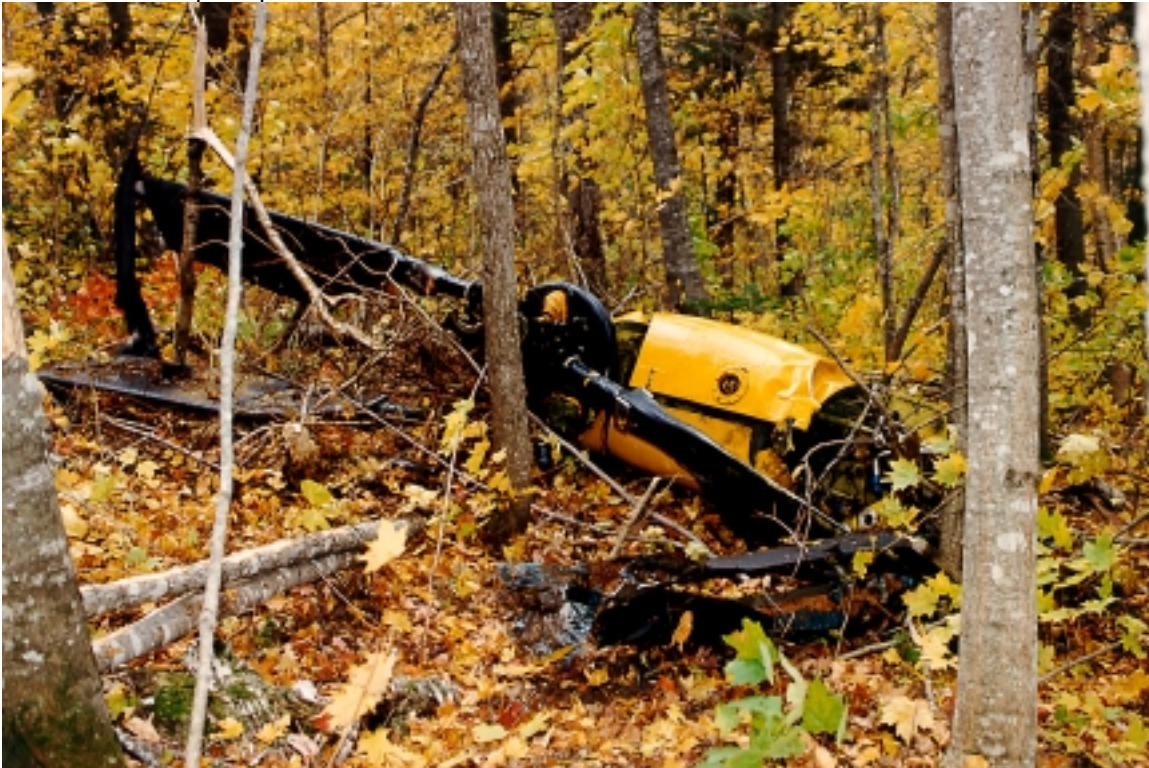
Photo 6 - Site 2 Rear Pylon and Rear Rotor blades (note undamaged surrounding trees)// Secteur 2 : pylône arrière et pales du rotor arrière (remarquez les arbres intacts)

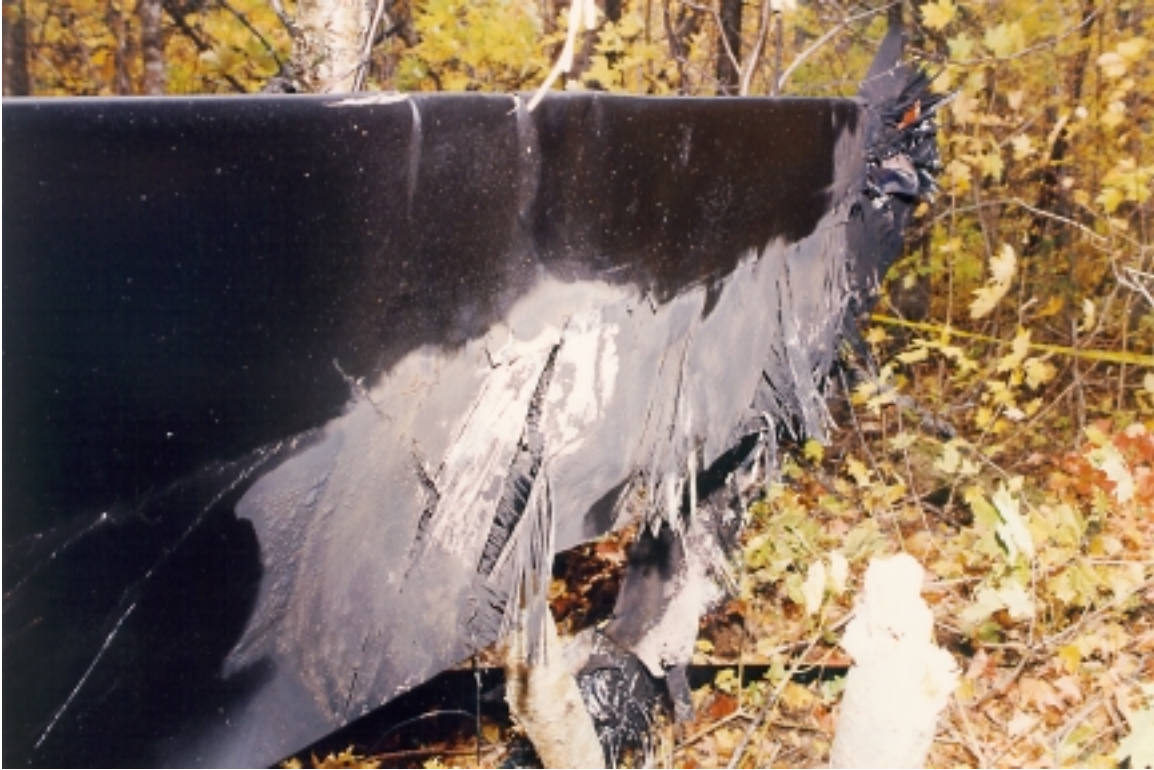
Photo 7 - Site 2 - Burnt Rear Rotor Blade// Secteur 2 : pale du rotor arrière brûlée

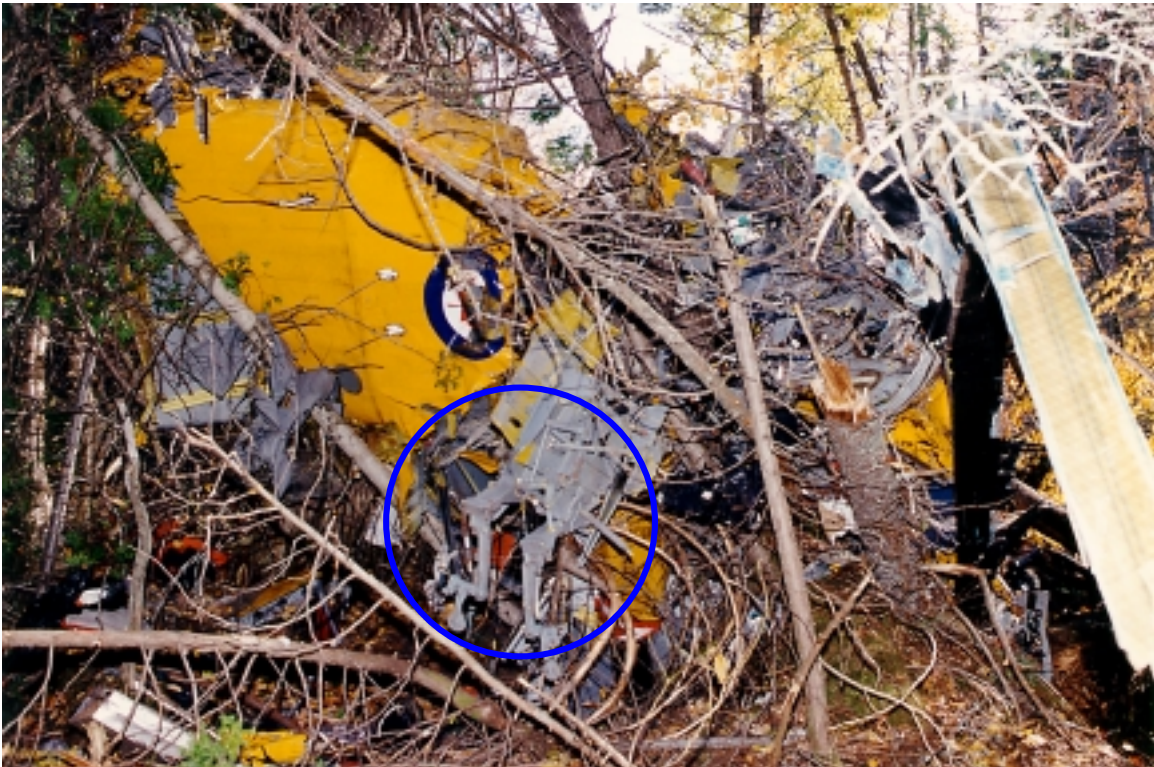
damage but minimal heat and fire damage except for some soot accumulation in the roof of the cabin area at the fuselage break (Photos 8-9). The forward rotor blades showed extensive rotational damage on the leading edge and all were damaged on the trailing edge. Many pieces of cabin equipment showed evidence of heat damage. There was evidence of blade to fuselage contact. The aircraft suffered 'A' Category damage.

Photo 8 - Site 1 - Forward Fuselage, Flight Station (circled) and bottom of aircraft// Secteur 1 : fuselage avant, poste d'équipage (encerclé) et bas de l'appareil

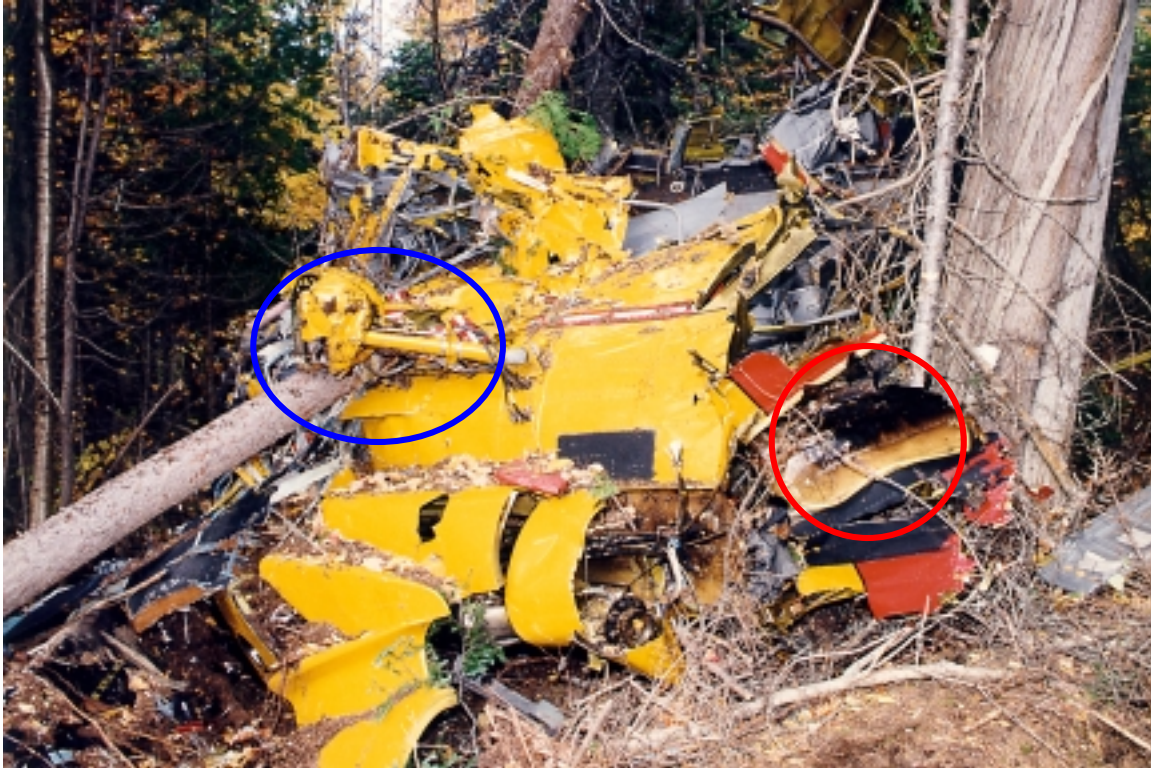
Photo 9 - Site 1 - Top and right side of Fuselage, Rescue Hoist (blue) - note the small fuselage burn top of Sync Shaft Tunnel area (red)// Secteur 1 : haut et côté droit du fuselage, treuil de sauvetage (en bleu) – remarquez la partie brûlée du fuselage en haut du tunnel de l'arbre de synchronisation (en rouge)

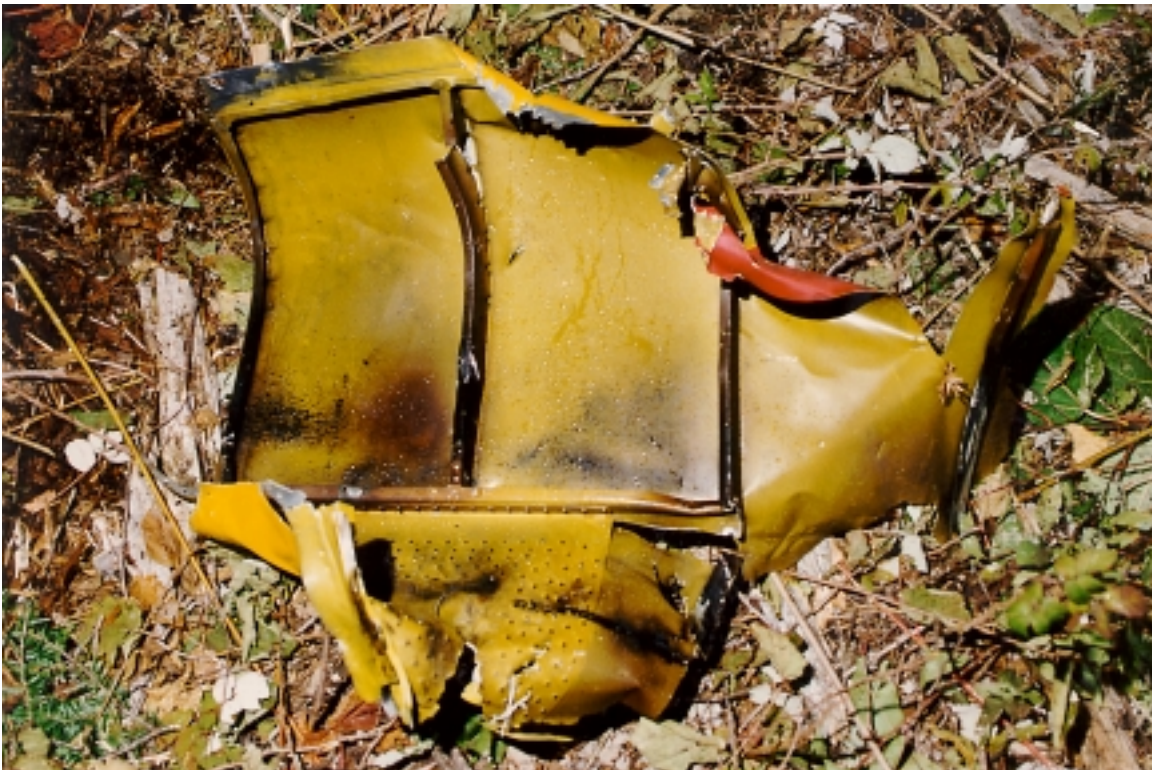
Photo 12 - Debris in Upper Field - Tunnel Cover Removed during first blade to fuselage strike (note soot on inside right)// Débris récupérés dans le secteur supérieur : carter du tunnel arraché lors du premier contact entre les pales et le fuselage (remarquez la suie sur le côté droit de la surface intérieure)

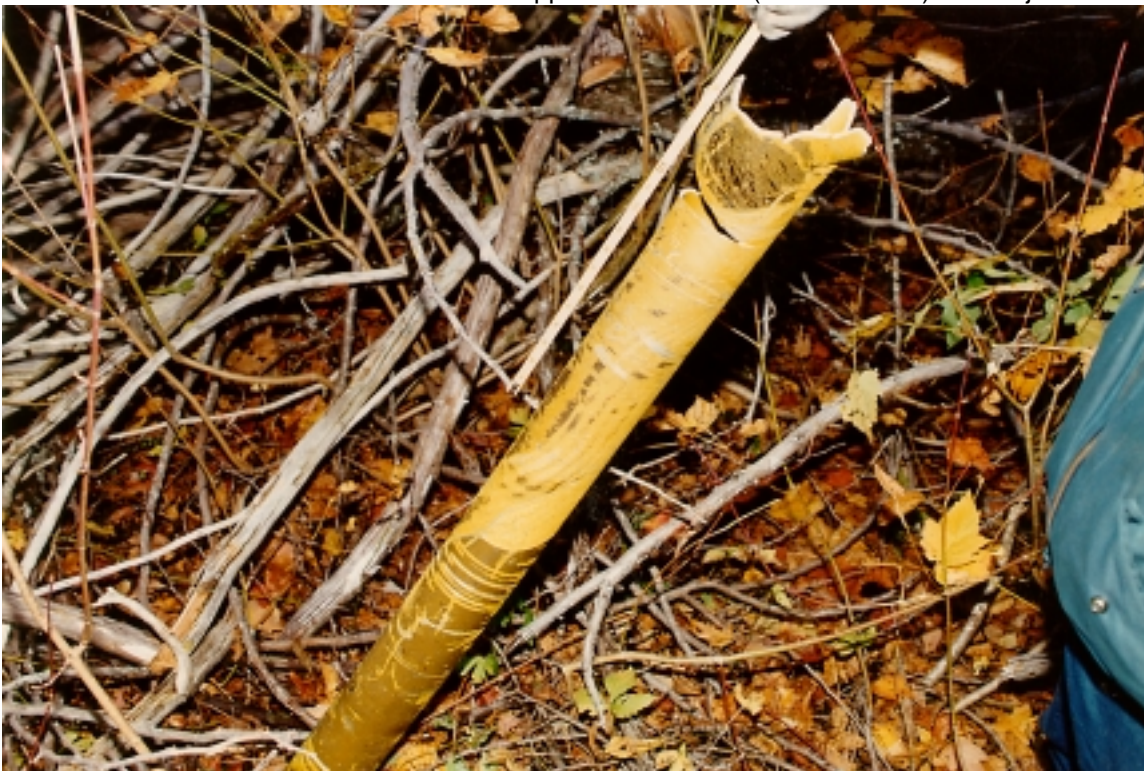
Photo 13 - Sync Shaft Fragment - Upper Debris field//– Morceau de l'arbre de synchronisation récupéré dans le secteur supérieur

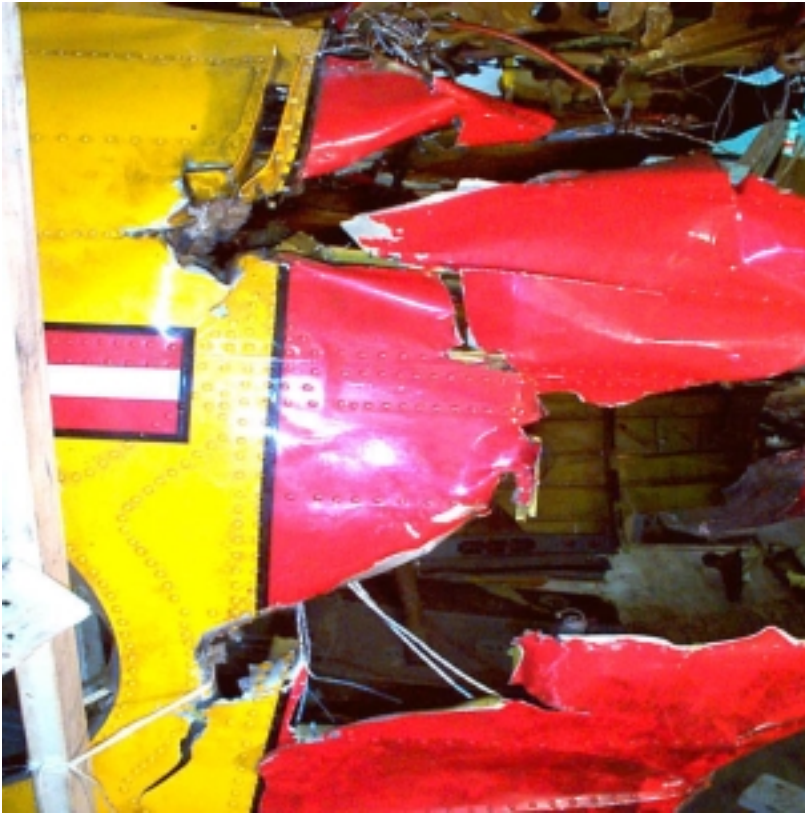
Photo 15 - Blade Strike holes in Fuselage// Perforations causées par les contacts entre les pales et le fuselage

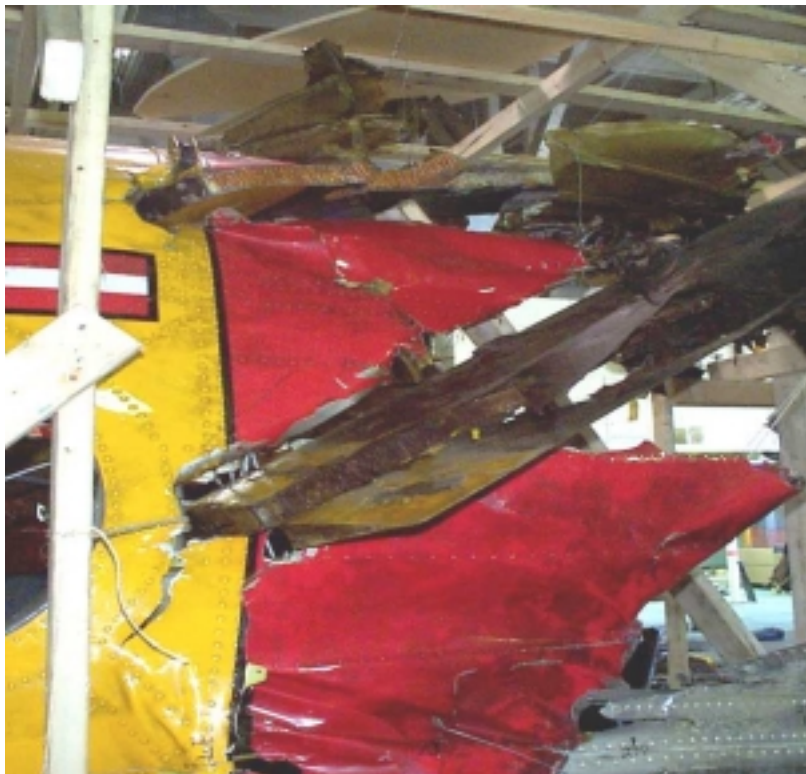
Photo 16 - Blade Pieces Inserted in Fuselage (confirming only 2 blades made all 4 cuts in fuselage).// Morceaux de pales enfoncés dans le fuselage (confirmant que les quatre entailles dans le fuselage sont attribuables à deux pales).

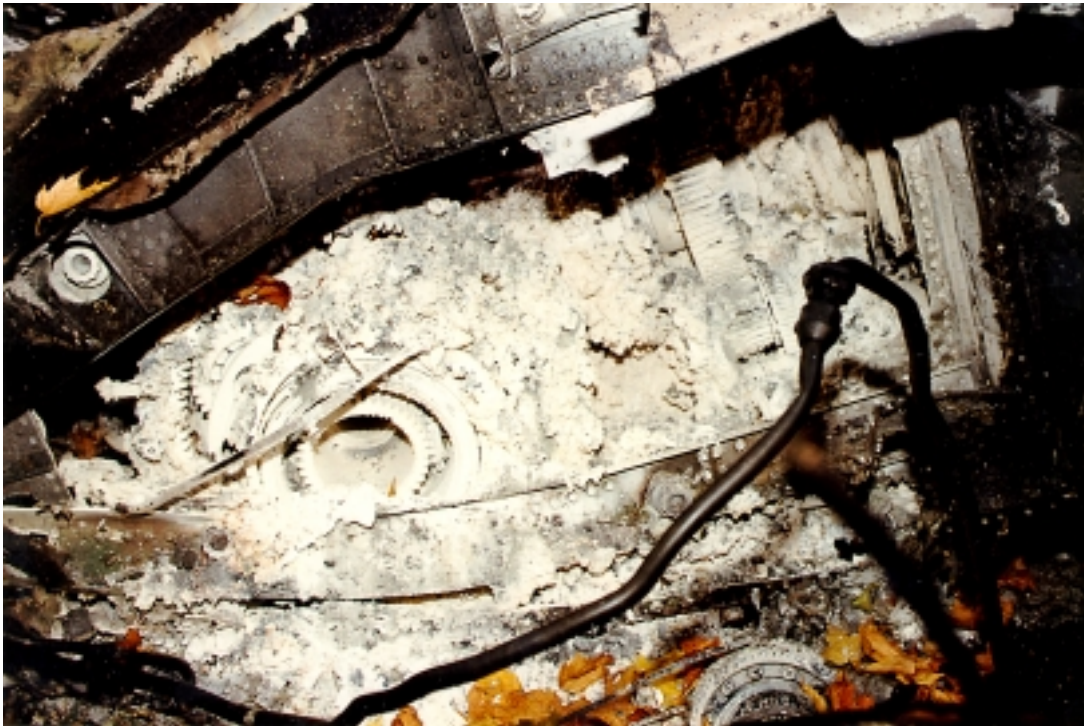
Photo 17 - MGB Gears and Ash of Outer Casing// Engrenages de la boîte de transmission principale et cendres du carter extérieur

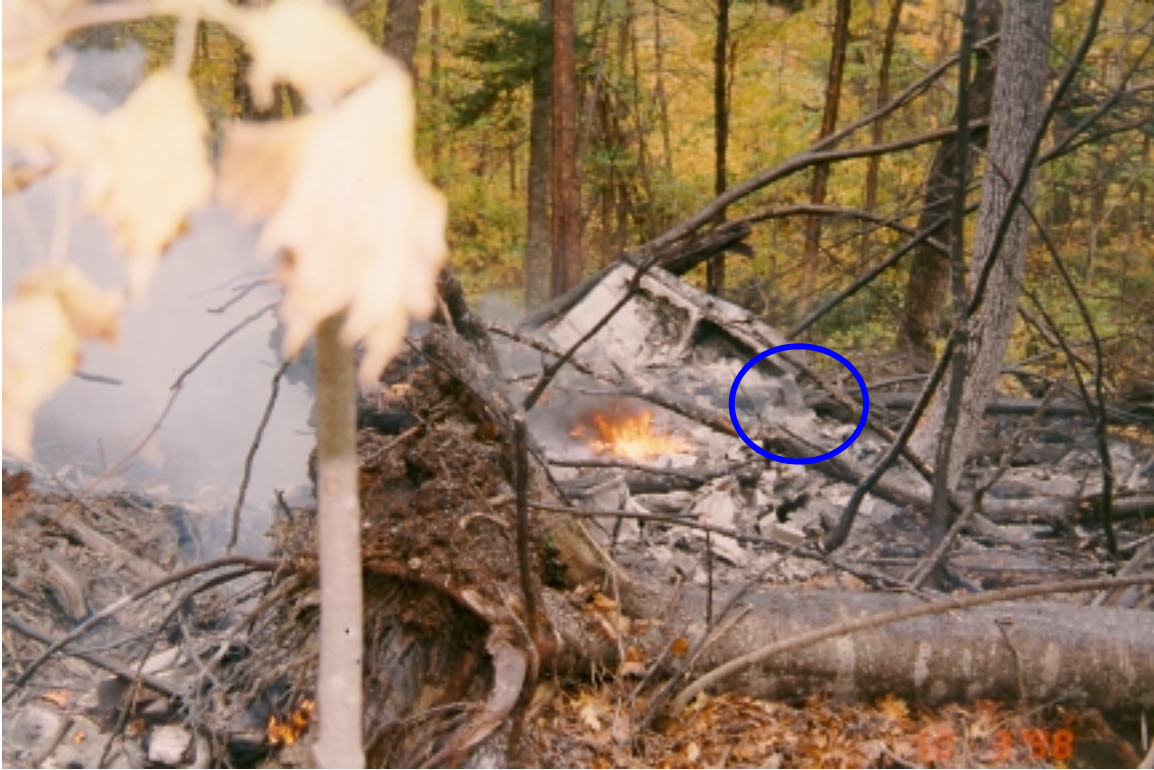
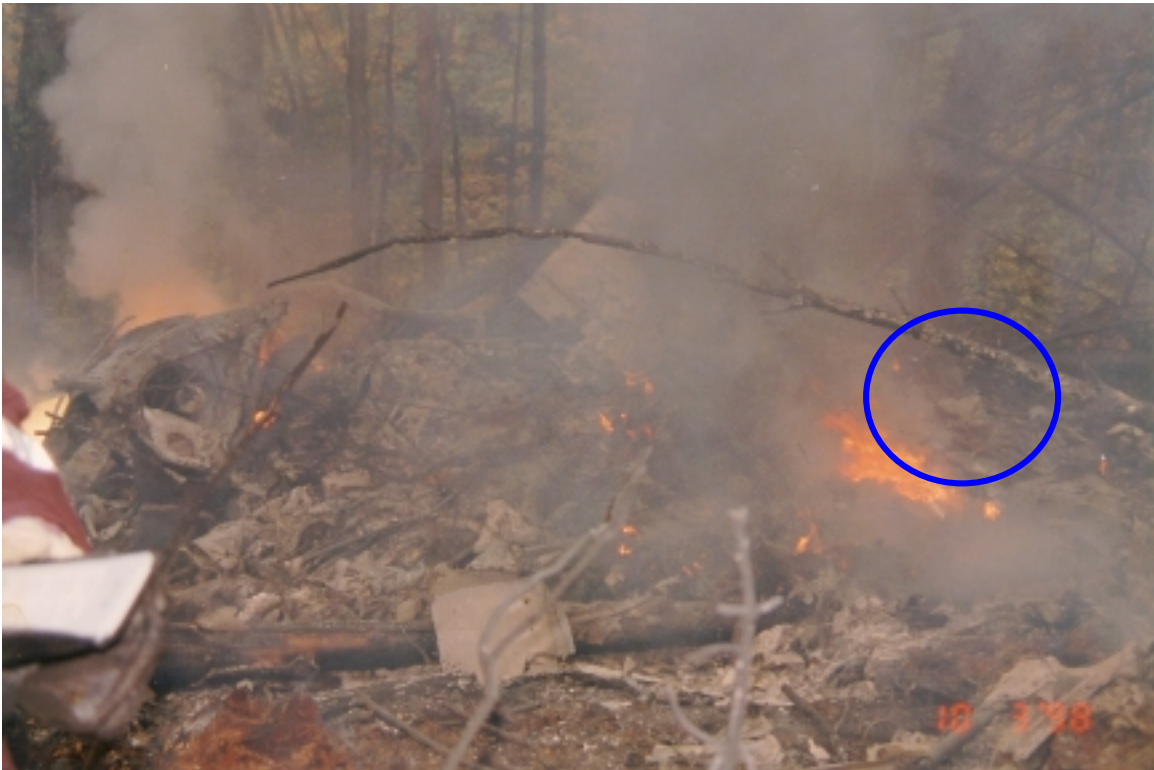
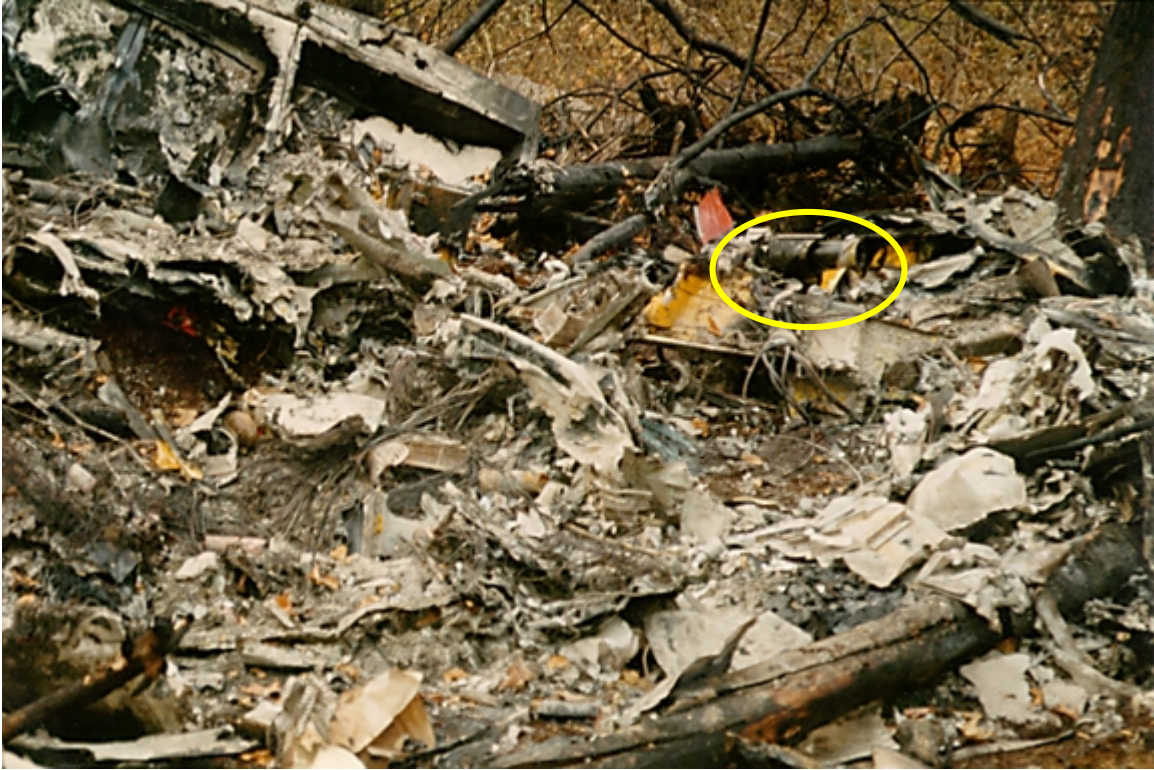
During the examination of the fuel dumping system in the hanger in Ottawa, the investigation team suspected that the fuel dump tube positions during aircraft impact were different from the position that they were found in by the team on the accident site. A photograph versus time inventory revealed that the tube position and their location changed from the first photographs taken to the last group of photographs, probably due to their being inadvertently disturbed during the post-crash activities (Photos 23-25).

Photo 23 - Left Dump Tube (extended and circled) in post-crash fire// Tube gauche du vide-vite (en extension et encerclé) lors de l'incendie ultérieur à l'écrasement

Photo 24 - Left Dump Tube (extended and circled) in fire immediately post crash// Tube gauche du vide-vite (en extension et encerclé) lors de l'incendie, immédiatement après l'écrasement

Photo 25 - Left Dump Tube as found on day 3 (retracted and circled)// Tube gauche du vide-vite tel qu'il était lorsqu'on l'a retrouvé au jour 3 des recherches (rentré et encerclé)

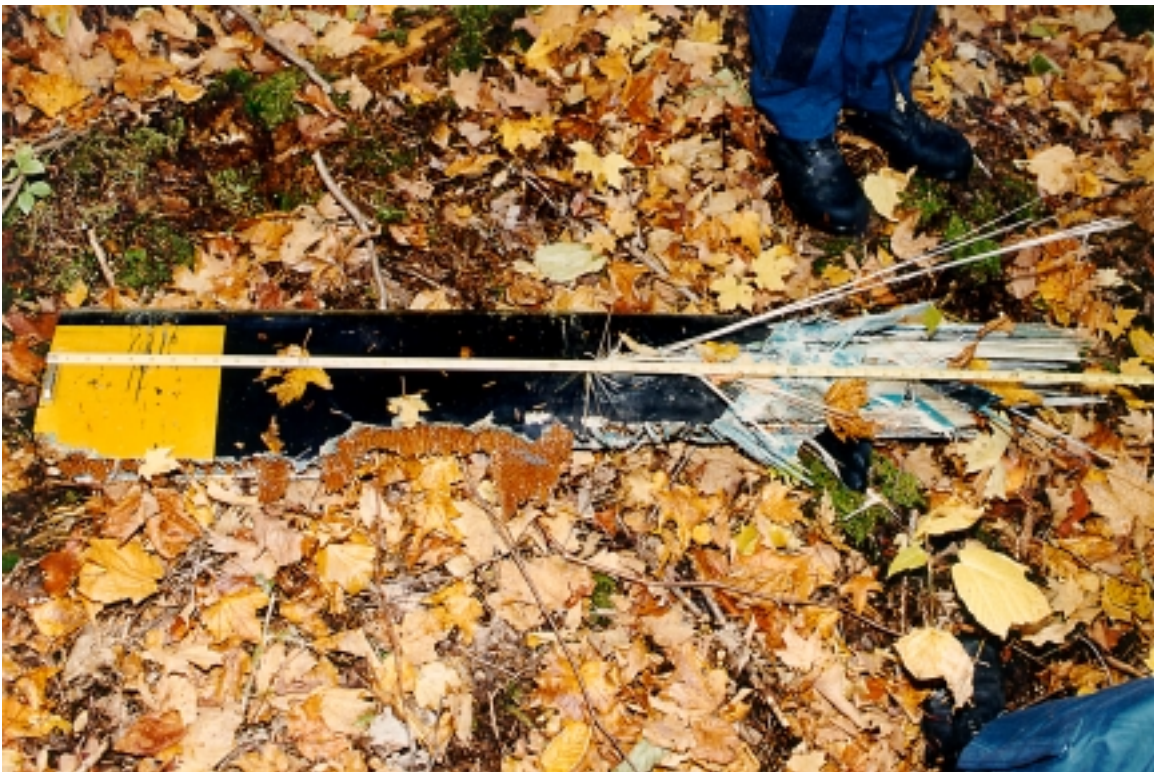
Photo 26 - Rear Rotor Red Blade Fragment - Note the unburned and frayed ends// Fragment de la pale rouge du rotor arrière; remarquez les bouts, non brûlés et « effilochés »

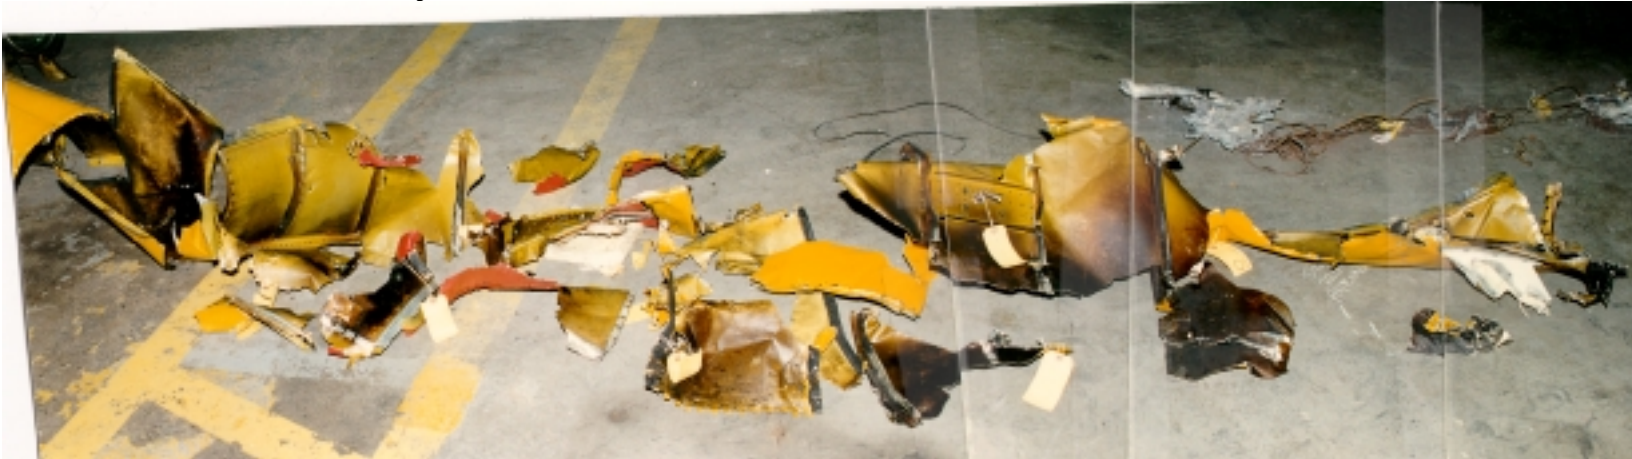
Photo 28 - Sync Shaft Tunnel Cover re-build (interior)(note soot on interior right side)// Reconstitution du carter du tunnel de l'arbre de synchronisation (intérieur) (remarquez la suie à l'intérieur, sur le côté droit)

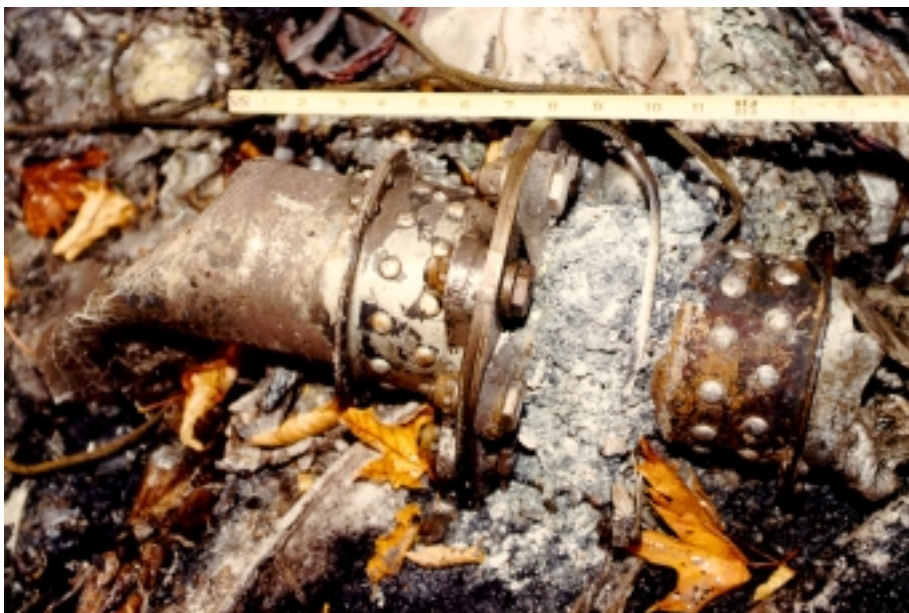
still attached (Photo 29). This damage pattern suggested these sections of the sync shaft were melted in the post crash fire.

Photo 29 - Thomas Coupling and melted Sync shaft sections// Raccordement de Thomas et sections fondues de l'arbre de synchronisation.

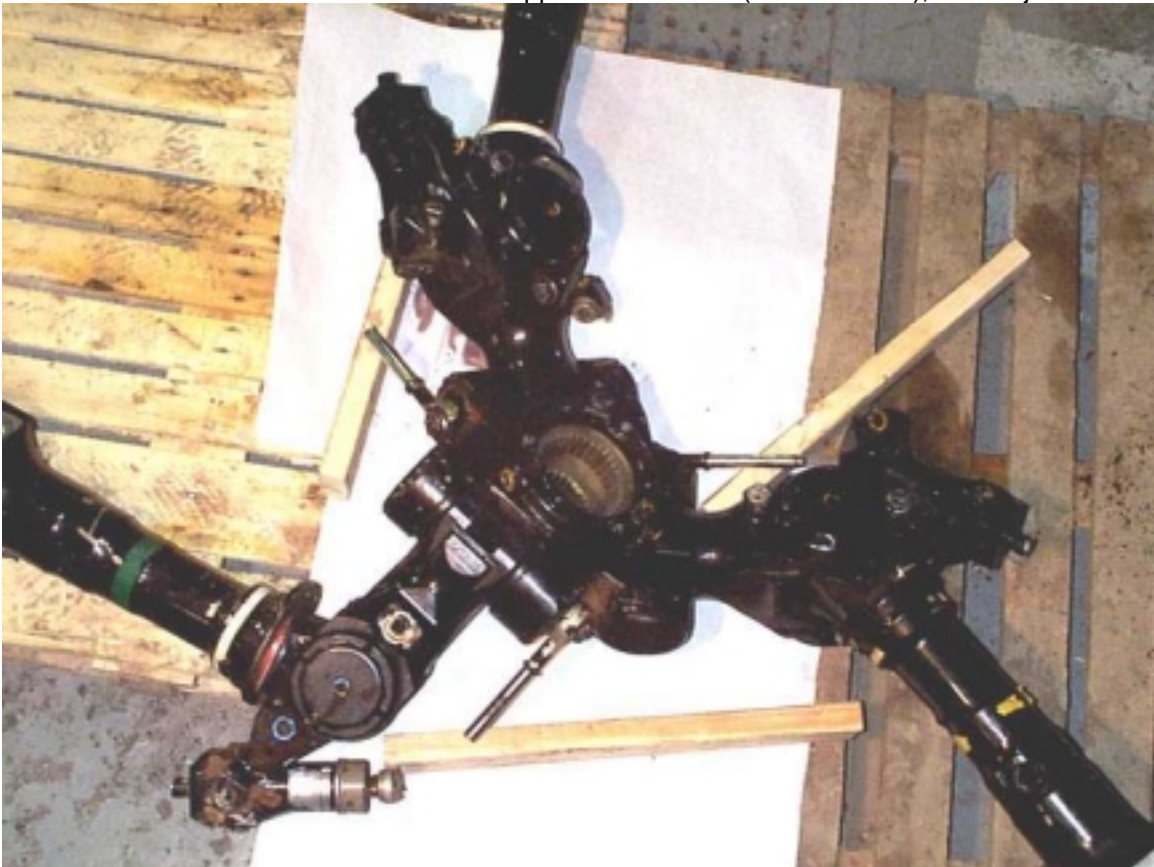
Photo 30 - Rear Rotor Head - Note Damper Failures in full extension// Tête du rotor arrière; remarquez les défaillances des amortisseurs en extension complète

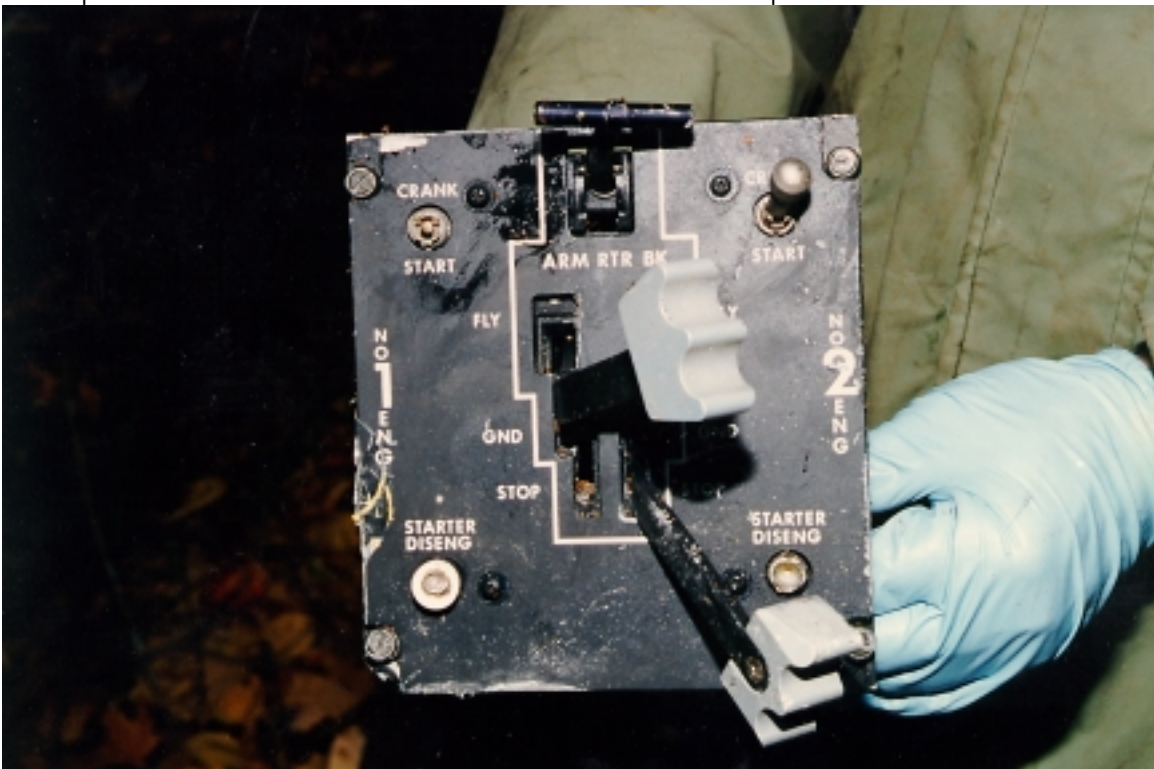
The #2 engine control lever (ECL) was in stop (Photo 31), the engine control actuator (ECA) was in the off position and the fuel control unit (FCU) was closed. The number 2 engine 'T' handle was found seated to the "in" position, damaged and in contact with a piece of wood debris (Photo 32). The number 2 engine oil shutoff valve was found in the open position. The number 2 engine fuel shutoff valve, located in the right stub wing fuel tank, was so badly damaged by fire that its position could not be discerned. All of the corresponding fuel controls on the number 1 engine were found in the fly position.

Photo 31 - Throttle Quadrant - Note Number 2 in "Stop" position// Bloc manettes; remarquez le numéro deux, en position « STOP »

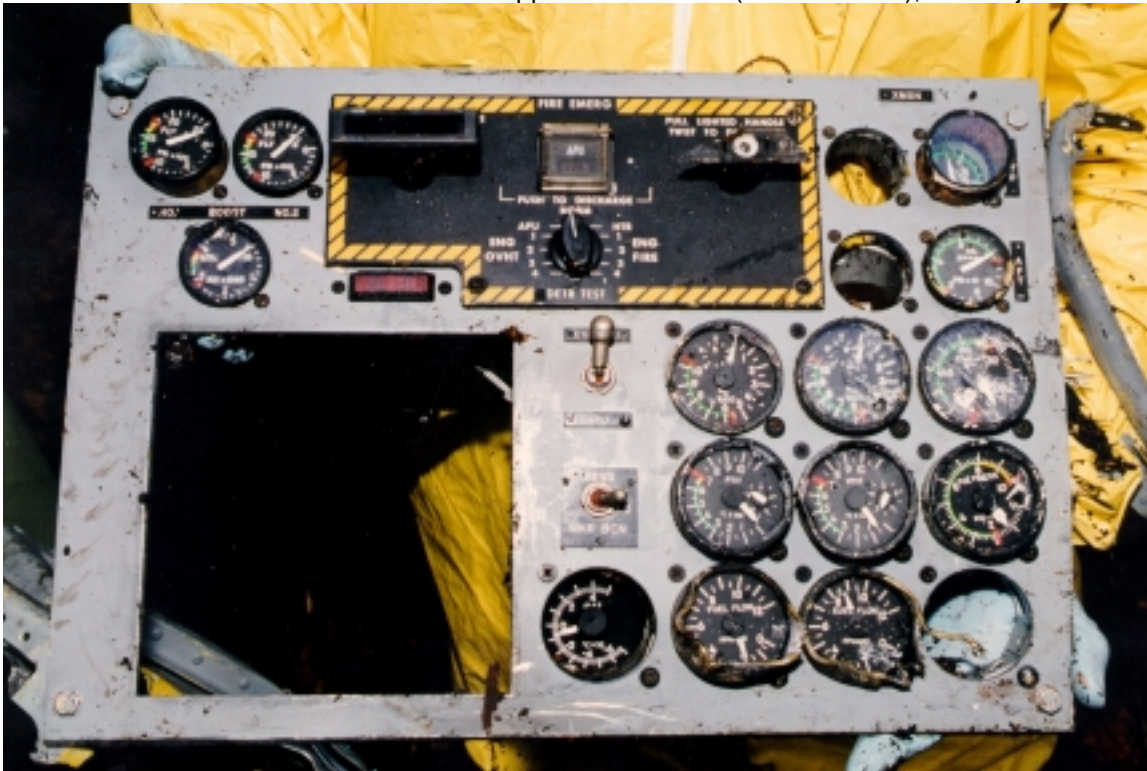
Photo 32 - Fire Extinguisher Control Panel - Note damage to Number 2 "T" handle// Panneau de commande du circuit d'extinction incendie; remarquez les dommages sur la poignée en T numéro 2

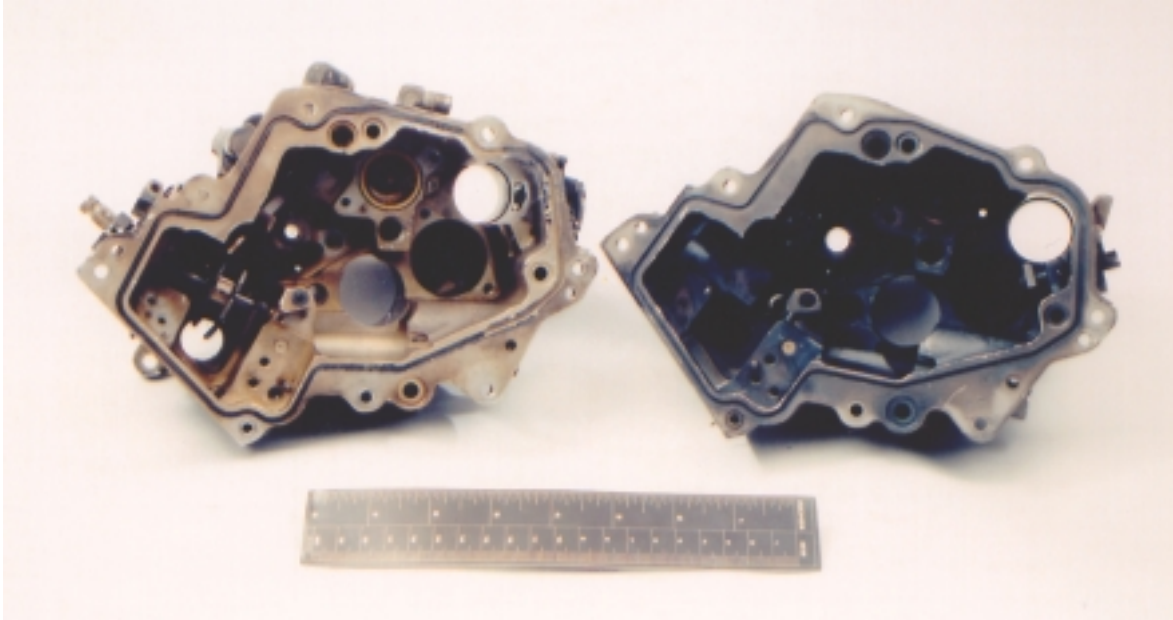
Photo 34 - Inside Views of #2 Engine Fuel Control Unit (left) and #1 FCU (right) - Note the lack of fuel residues on #2 // Vues de l'intérieur du régulateur de carburant du moteur numéro 2 (à gauche) et de celui du moteur numéro 1 (à droite); remarquez l'absence de résidus de carburant dans le FCU du moteur numéro 2

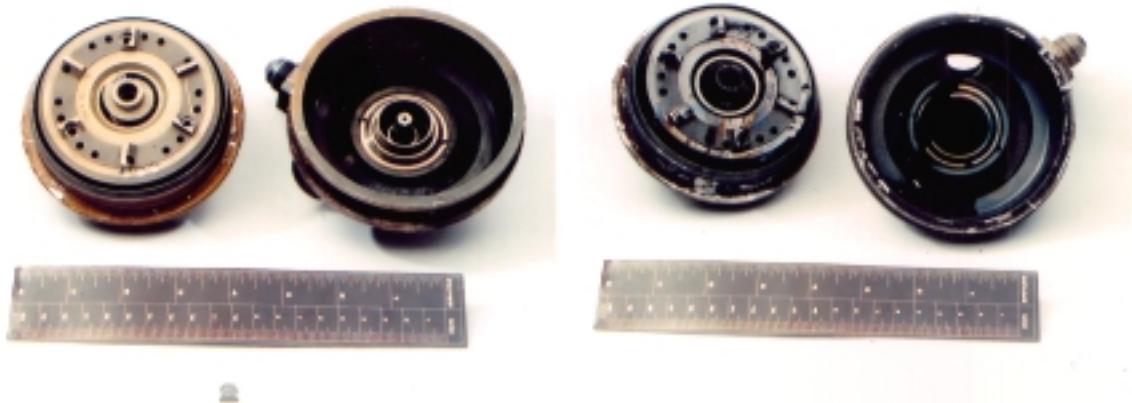
Photo 35 - Inside Views of #2 Engine Centrifugal Fuel Purifier (left) and #1 Purifier (right) - Note similar lack of fuel residues on #2 Purifier // Vues de l'intérieur de l'épurateur carburant centrifuge du moteur numéro 2 (à gauche) et de l'épurateur du moteur numéro 1 (à droite); remarquez, ici encore, l'absence de résidus de carburant dans l'épurateur du moteur numéro 2

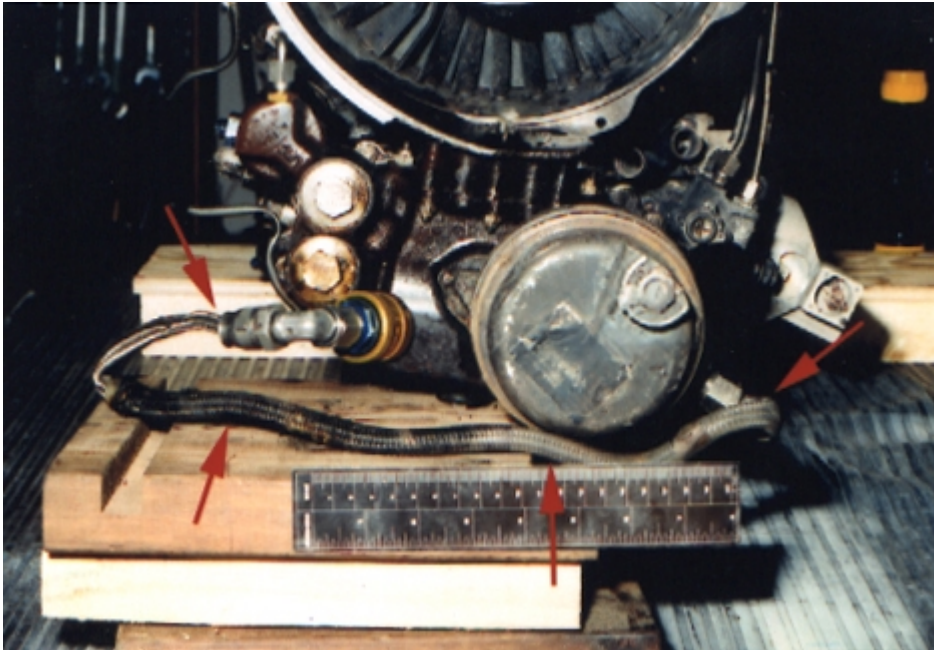
Photo 37 - #2 Engine Main Fuel Line (suspected location of original fuel leak - Note fire damage to cable) // Conduite principale d'alimentation en carburant du moteur numéro 2 (que l'on suppose être à l'origine de la première fuite de carburant; remarquez les dommages que le feu a causés au câble)

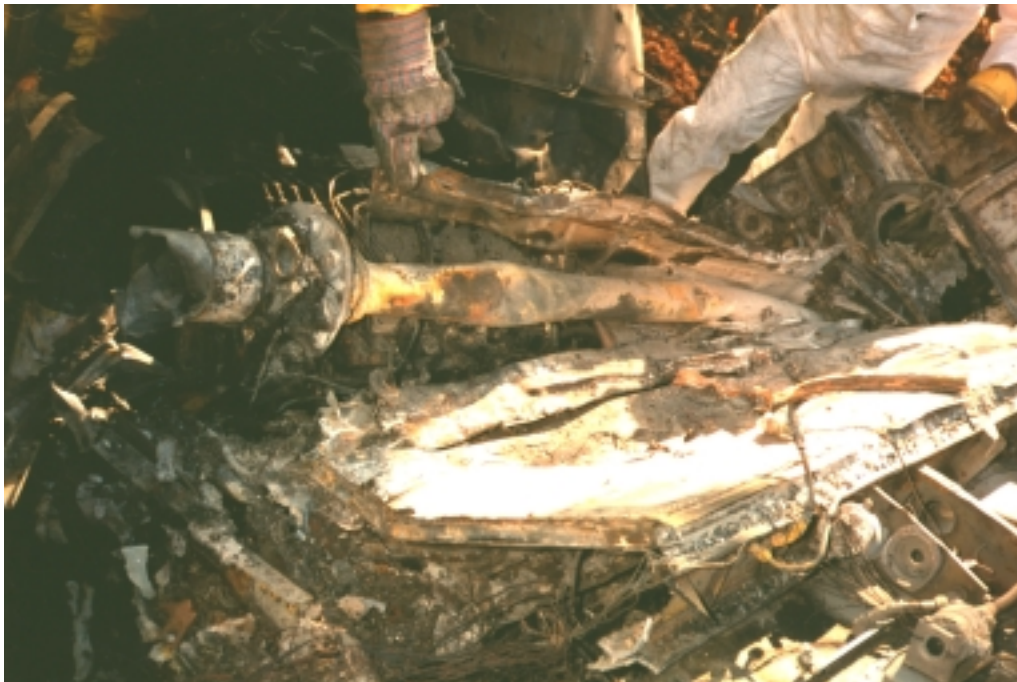
Photo 39 - Engine Compartment (steel) Sync Shaft - Note discoloration due to heat (Number 1 engine door in foreground) // Compartiment moteur (acier) et arbre de synchronisation; remarquez la décoloration imputable à la chaleur (porte d'accès au moteur numéro 1 en avant-plan)
